# SC/68D/HIM/04

**CCAMLR – IWC coordination: Incidents of whale bycatch in the Antarctic krill fishery**

**Further information requested by WG-FSA-21 on humpback whale (*Megaptera novaeangliae*) mortality incidents recorded by the krill fishery in Subareas 48.1 and 48.2 during the 2020/2021 season**

### **REPORT: HUMPBACK WHALE CARCASSES IN 2020/21 SEASON**

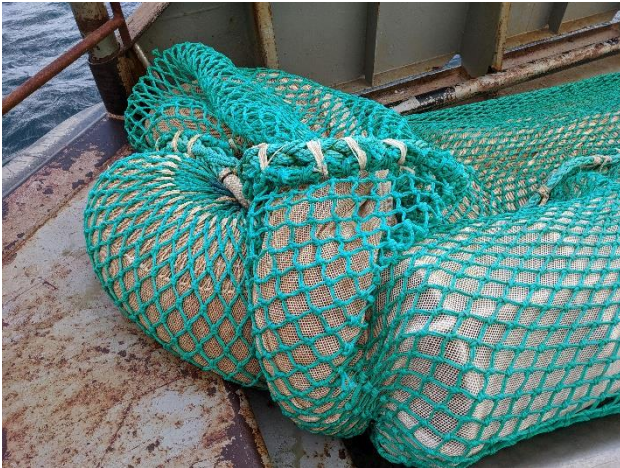
Net weighting was used in accordance with the declared gear in the vessel notification. The observer found the net to be very clean after every haul. Any required cleaning of the net or deck was minimal. No krill or other bycatch was available to birds or mammals during or after shooting. Any remaining krill at the codend, typically less than 100 kg, was retained in the codend until subsequent shooting (Figure 1).

**Figure 1 Residual krill in the codend**

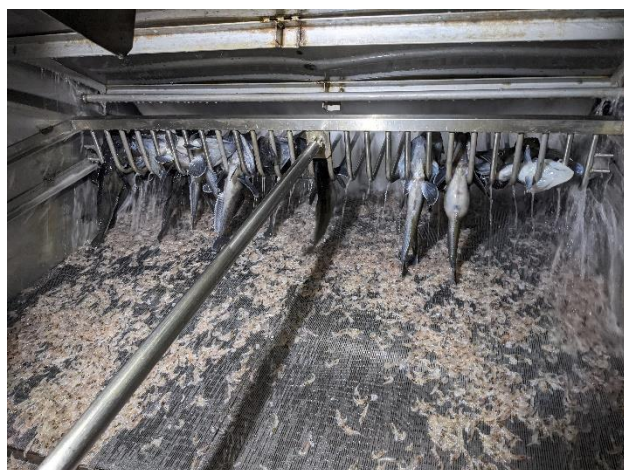
During several trawls, large volumes (>500 kg) of *Pseudochaenichthys georgianus*, *Chaenocephalus aceratus* and *Champsocephalus gunnari* were separated from the catch, placed in 500 kg meal bags, weighed, and number estimated from a sub-sample of individual weights.

**Figure 2 Large bycatch caught in the dewatering grid**

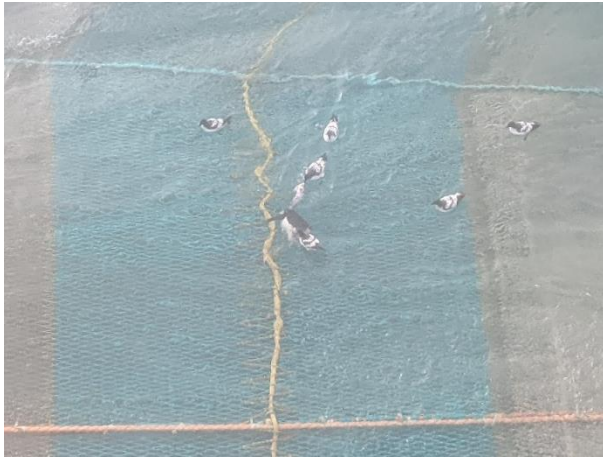
22 seabirds were observed to become entangled during the trip. During the shooting of trawl 1642, a dead Chinstrap penguin was seen to fall out of the starboard net (Fig. 3). It is unclear how the penguin came to be in the net, but a potential cause is that during hauling of the driftline, the net collapsed around the bird and entangled it. Two penguins were observed standing on the port net during the preceding haul but moved off the net before it was retrieved. No penguins were observed on the starboard net during the preceding haul.

**Figure 3 Dead penguin observed during hauling of trawl 1642**

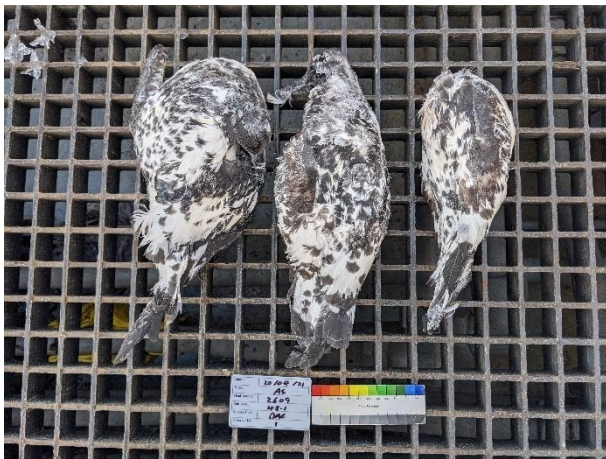
During hauling of trawl 2609, very large numbers of birds (>1000) were present around the vessel, associated with a dead humpback whale (*Megaptera novaeangliae*) in the codend. During hauling, five Cape petrels (*Daption capense*) were seen to become entangled in the mouth of the net and drowned. Two other Cape petrels were seen to become entangled and successfully free themselves from the net. Three of the birds were recovered by the crew and handed to the observer after hauling; one was seen to fall out of the net during the subsequent shoot (2612) and one was not recovered.

**Figure 4 Three dead cape petrels retained from trawl 2609**

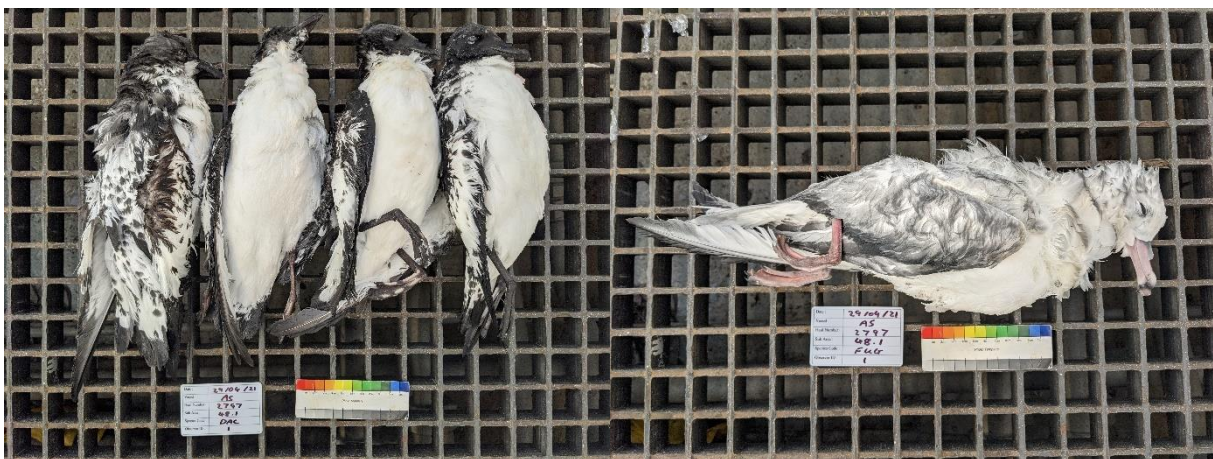
During hauling of trawl 2797, very large numbers of birds (>1000) were present around the vessel, associated with a dead humpback whale in the net intermediate. During hauling, five Cape petrels and one Southern Fulmar (*Fulmarus glacialisoides*) were seen to become entangled in the mouth of the net and drowned. Two other Cape petrels were seen to become entangled and successfully free themselves from the net. Four of the Cape petrels and the Southern Fulmar were recovered by the crew and handed to the observer after hauling (Figure 5); one Cape petrel was not recovered.

**Figure 5 Four dead cape petrels and one southern fulmar retained from trawl 2797**

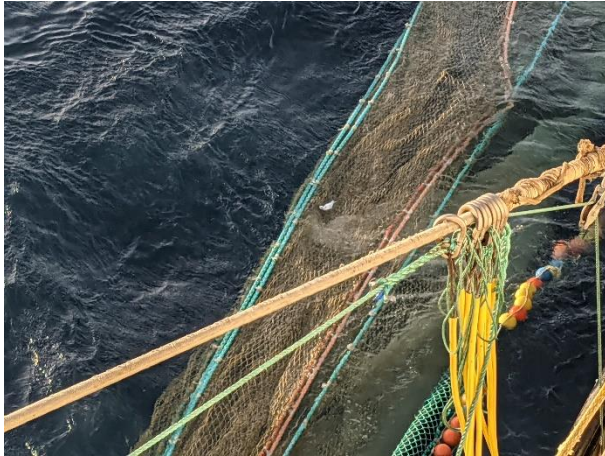
During hauling of trawl 3159, one snow petrel (*Pagodroma nivea*) was seen to become entangled in the mouth of the net and drowned. The bird was seen to fall out of the net during the subsequent shot (Figure 6).

**Figure 6 Dead Snow Petrel (PWP) caught during hauling of trawl 3159 drifting free of the net during shooting of trawl 3160.**

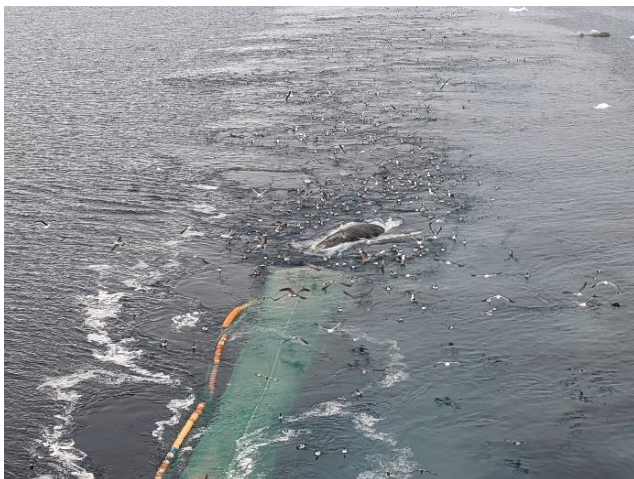
An exclusion panel with a 16mm inner mesh and 144mm outer mesh was located at the mouth of the trawl (Figure 7). The net was observed to be clean on all hauls. There was no noticeable loss of krill during hauls. Any potential residual krill in the codend was inaccessible to marine mammals due to the exclusion panel. Humpback whales (*Megaptera novaeangliae*) were seen to follow the net during several hauls (Figure 8).

**Figure 8** Humpback whale following the net

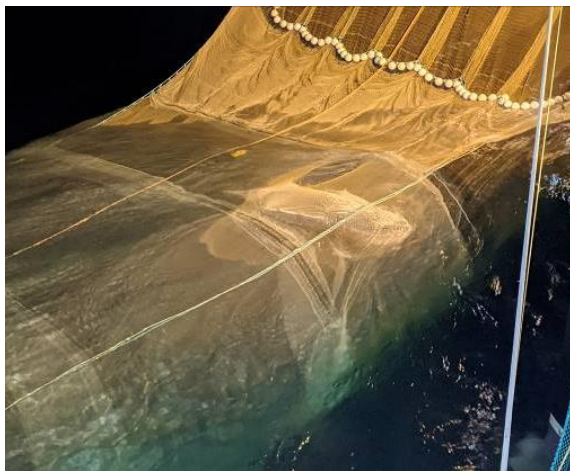
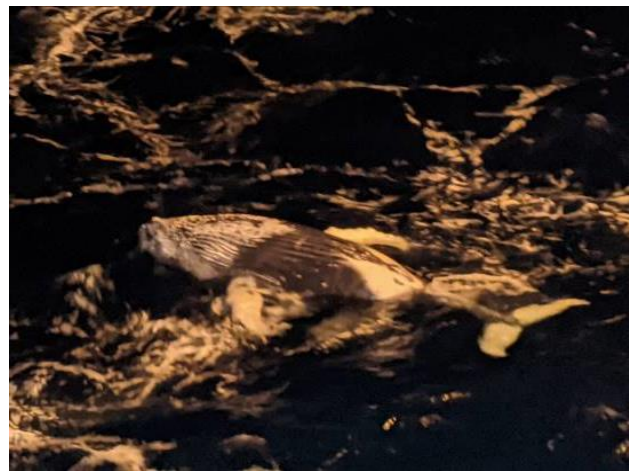
Three humpback whales were hauled dead during the deployment. In each case the carcass was in poor condition and produced a strong smell. It is possible they entered the net already dead.

At 03:20 on 04/03/2021 (position -60° 32, -45° 11), whilst hauling the net to repair a damaged section of hose, a dead humpback (estimated 8-10m in length) was caught in the mouth of the net, against the marine mammal exclusion panel. The carcass was bloated and blood was seen leaking into the water. After one hour, the carcass was released and floated free. A 1m rip was found in the upper mouth of the net, consistent with the location of the carcass. The observer was on watch throughout; no other IMAF or warp strikes associated with this event were observed.

**Figure 9 Whale caught inside net on 04/03/2021**

**Figure 10 Whale carcass floating free after release on 04/03/2021**

- 1m rip in mouth of net from where the carcass had come to rest was repaired
- No more action taken, fishery resumed

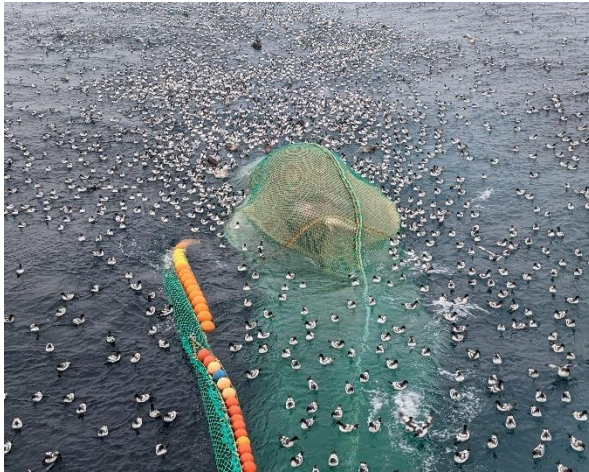
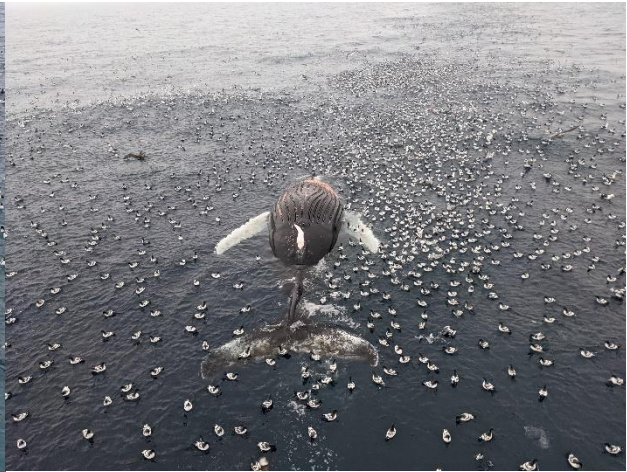
At 18:30 on 20/04/2021 (position -63° 33, -59° 24) a dead humpback (estimated length of 7-8m) was found in the codend during hauling. The carcass was bloated and blood was seen leaking into the water. One hour later, most of the net was hauled and the codend opened to release the carcass. Very large numbers of birds (>1000) were present throughout this event and five cape petrels were seen to become entangled in the mouth of the net and drowned. Two other birds were seen to become entangled and successfully free themselves from the net. Three of the birds were recovered by the crew and handed to the observer after hauling; one was seen to fall out of the net during the subsequent shoot (2612) and one was not recovered.

**Figure 11 Whale caught inside net on 20/04/2021**

**Figure 12 Whale carcass floating free after release on 20/04/2021**

- Codend and mammal exclusion device inspected and repaired
- Fishery operation continued in another area after 22 hours

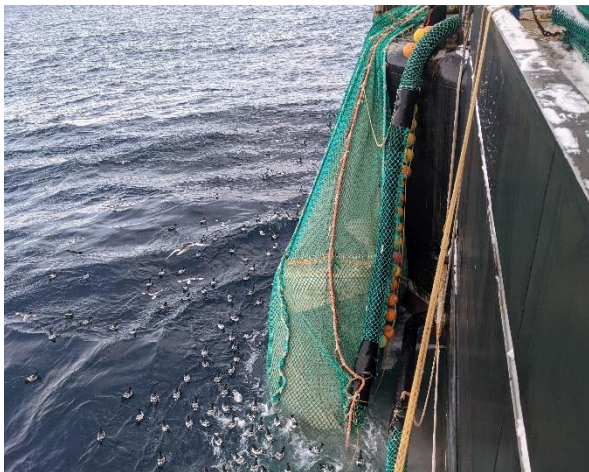
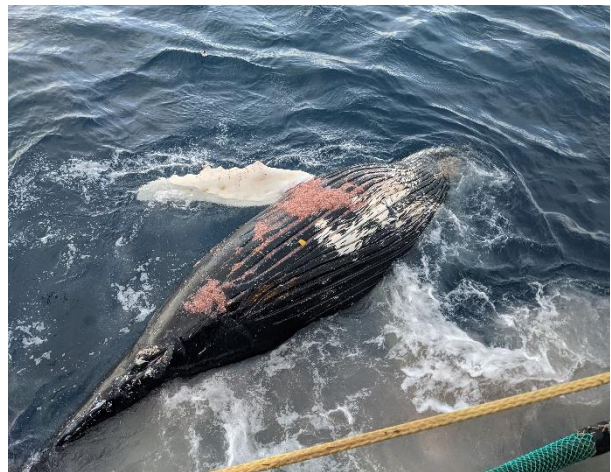
At 14:43 on 29/04/2021 (position  $-64^{\circ} 18$ ,  $-61^{\circ} 20$ ) a dead humpback (estimated length of 8-10m) was found in near the centre of the net during hauling. The carcass was bloated and blood was seen leaking into the water. One hour later, most of the net was hauled and the codend opened to release the carcass. Very large numbers of birds ( $>1000$ ) were present throughout this event and five cape petrels and one southern fulmar were seen to become entangled in the mouth of the net and drowned. Two other cape petrels were seen to become entangled and successfully free themselves from the net. Four of the cape petrels and the southern fulmar were recovered by the crew and handed to the observer after hauling. One cape petrel was not recovered.

**Figure 13 Whale caught inside net on 29/04/2021**

**Figure 14 Whale carcass floating free soon after release on 29/04/2021**
